# Manhole Inspection Summary

Manhole # S53W1\_006MH

Insp Date: **6/6/08 11:37 AM**

**Location** Address: **1955 Chesapeake Ave.**

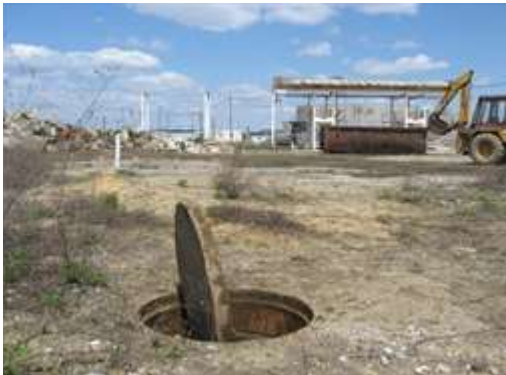
Location View

Comments **Chevron Property**

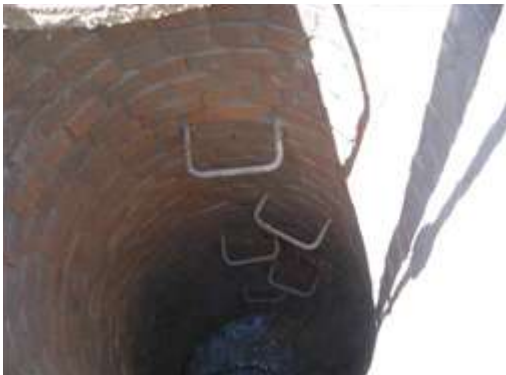
Steps

**Steps** Count: **9** Missing: **0** ☐ Corroded

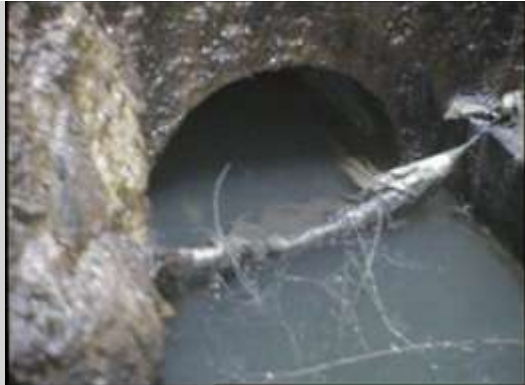
12 O'Clock Outflow

18 in. Circular Gravity Sewer  
Pipe Out @ 12 O'Clock

Pipe Height: **19.2** (in.) Rod and Bar (Angled)  
Pipe Material: **Clay** ☐ Pipe Lined  
Invert Depth: **15.60** (ft.) Flow Characteristics: **Slow**  
Deposits: ☐ None ☐ Mud ☒ **Sludge** ☐ Debris ☐ Grease  
Silt Depth: **8** (in.) Deposits Extent: **Medium**  
Infiltration: **None** Pipe Seal Cond: **Sound**

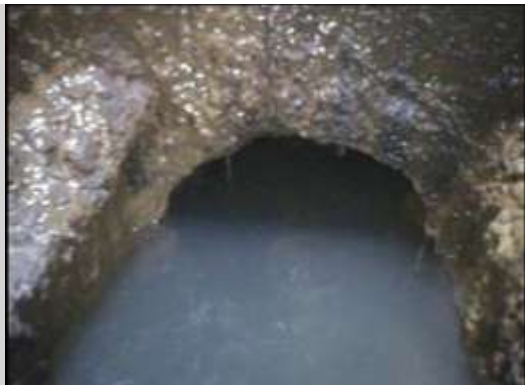
9 O'Clock Inflow

18 in. Circular Gravity Sewer  
Pipe In @ 9 O'Clock

Pipe Height: **19.2** (in.) Rod and Bar (Angled)  
Pipe Material: **Clay** ☐ Pipe Lined  
Invert Depth: **15.55** (ft.) Flow Characteristics: **Slow**  
Deposits: ☒ None ☐ Mud ☐ Sludge ☐ Debris ☐ Grease  
Silt Depth: (in.) Deposits Extent:  
Infiltration: **None** Pipe Seal Cond: **Sound**
